Asbestos Abatement Techniques Were Key to the Mold Remediation Industry; Now Mold Technology May Return the Favor

Michael A. Pinto CSP, SMS, CMP, CFO, FLS

Wonder Makers Environmental

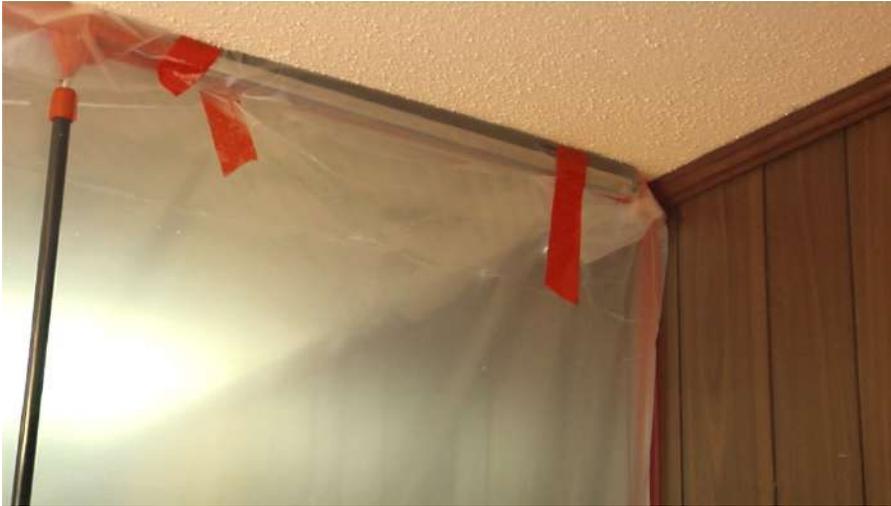
1. Isolation barrier installed to divide a room with asbestos popcorn ceiling into two distinct test areas

The bedroom with the asbestos ceiling was actually split in half with an isolation barrier. The ceiling on one half of the room was carefully covered with sheets of *MoldHold*. Air samples were collected on each side of the bedroom under two types of conditions (see figures 1-3).

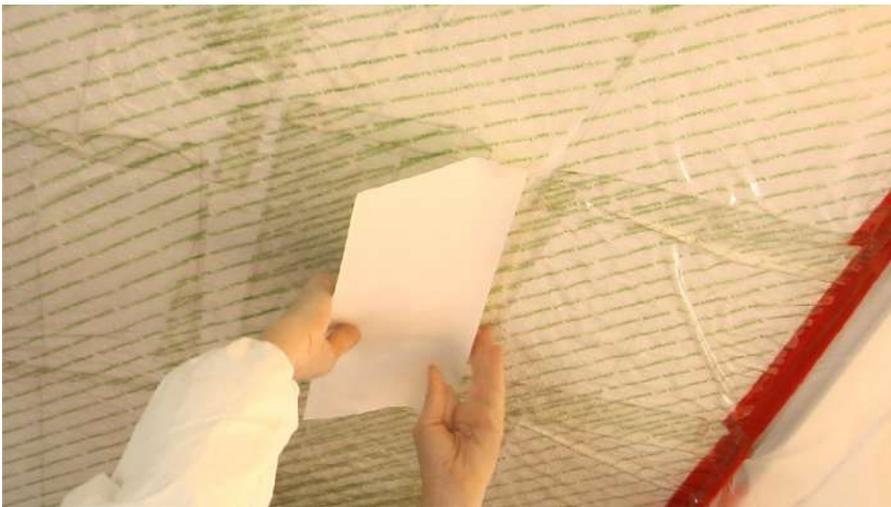
2. *MoldHold* sheets were applied to one side to minimize possible asbestos exposure

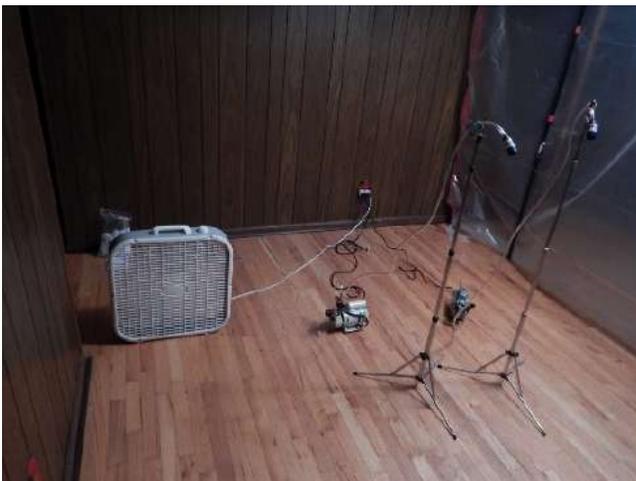
3. Air samples were taken while air was being agitated to simulate disturbance from floor fans during drying

It was important to determine what potential asbestos fiber concentrations would be with individuals moving about the work area as if they were packing up contents or doing an extraction. That sort of activity would represent more "normal" conditions; work steps that would not typically generate a lot of airborne fibers from friable asbestos material. The second simulated condition would be a water or fire restoration project that had moved on to the drying phase where dehumidifiers, negative air machines, and floor fans are utilized. The potential for this more aggressive air movement to dislodge fibers is well-documented in the asbestos literature. In this case, the airflow was simulated with a large box fan while the samples were being collected.

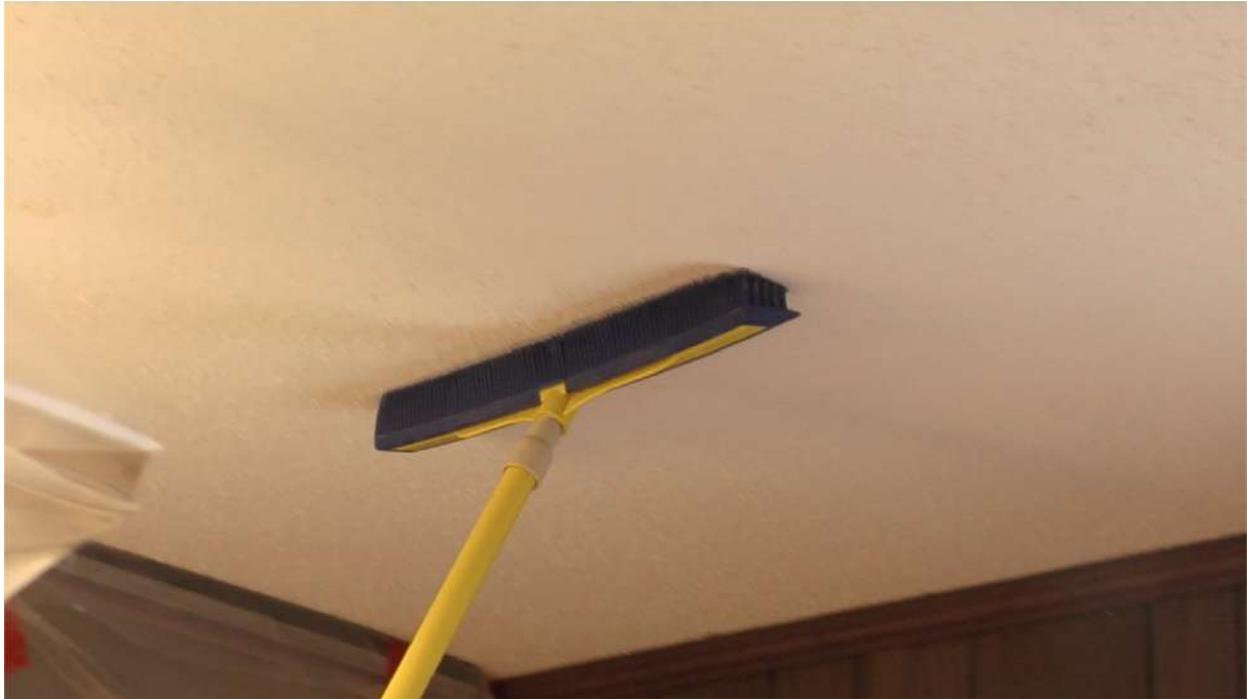
4. Additional samples were collected while the asbestos ceiling was intentionally disturbed; in this case by using a broom (3)

The fact that *MoldHold* showed real promise in minimizing potential asbestos contamination during simulated water or fire restoration activities was certainly exciting. A bit of a bonus was the fact that after the simulation related to a fire or water loss was completed, another test was conducted. The ceilings in each of the contained areas (one with *MoldHold* and one without), were intentionally impacted in order to simulate a potential fiber release episode. In this particular case, a broom was used to sweep across the surfaces. This activity was conducted to simulate what would happen in the case of an accidental impact to the ceiling from a tool or ladder.

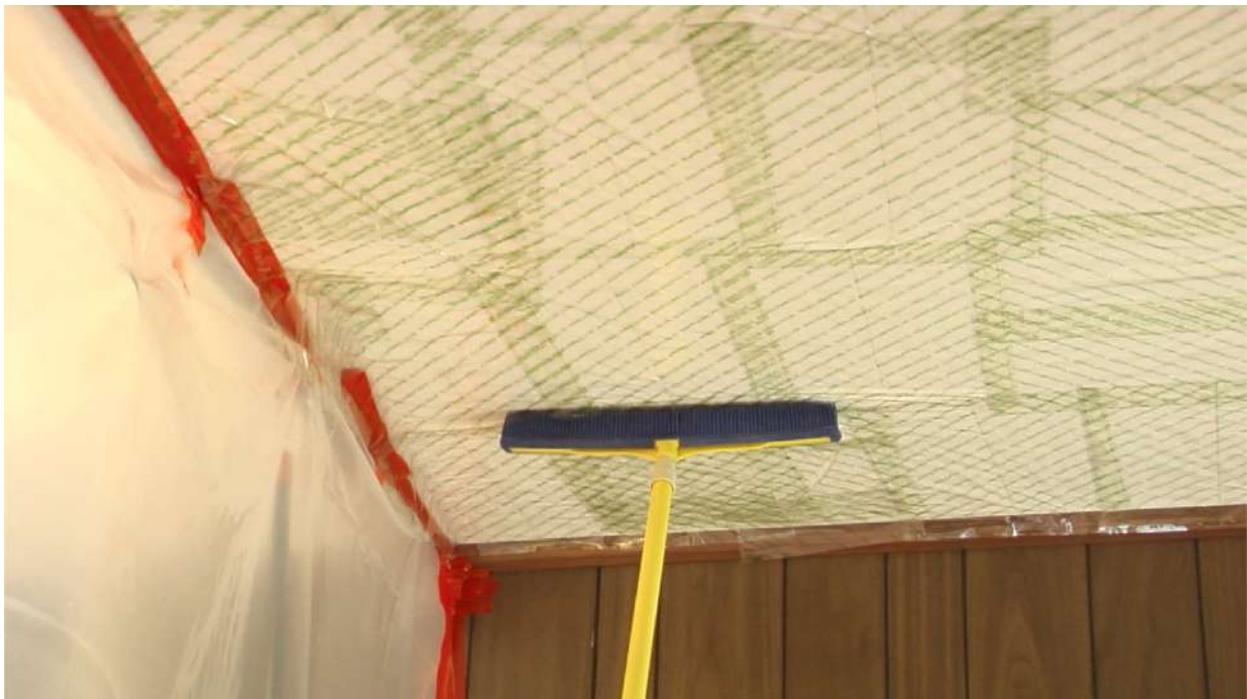
5. The *MoldHold* prevented worker exposure in case of an accidental impact with a tool or ladder; as simulated by the broom action used in both test spaces.

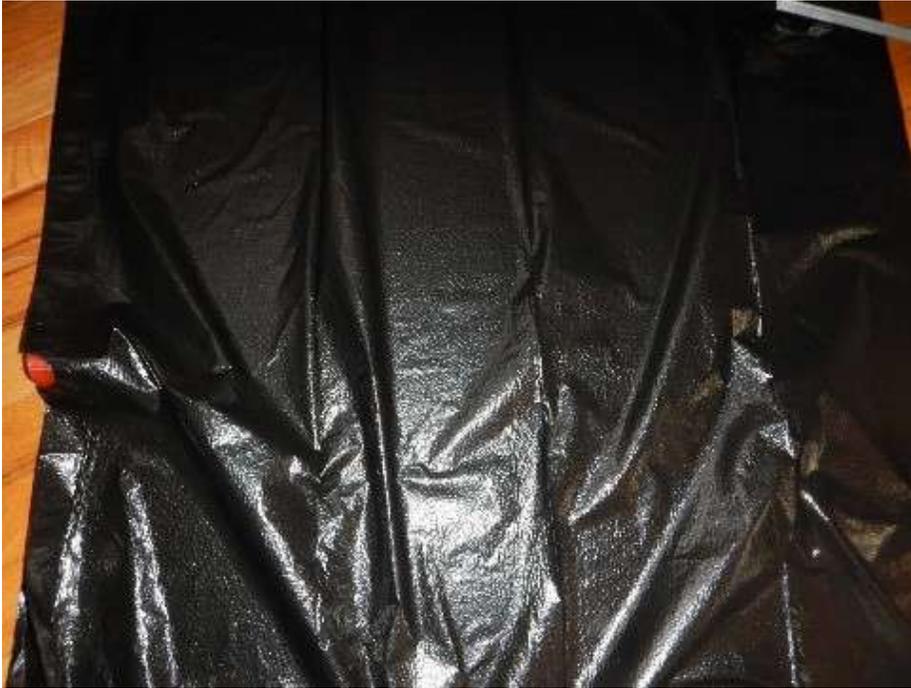
6. Black plastic was put down to show the contrast with the ceiling debris, but no particles were visible after brooming the ceiling of the room with *MoldHold*.

Several steps were taken to make sure that the procedures provided a reasonable representation of conditions after the intentional fiber release episode. Before any disturbance with a broom, black plastic was laid on the floor. The dark color would provide a much greater visual contrast for the white popcorn ceiling, if any was dislodged. The individuals conducting the tests were also careful to apply approximately the same pressure over a similar square footage of the ceiling in both isolated areas. The activities are illustrated in figures 4 - 7 with sample results summarized in the table below. Note that no surface samples were collected from the room with *MoldHold* on the ceiling, because there was no visible debris on the floor after the work activity was completed.

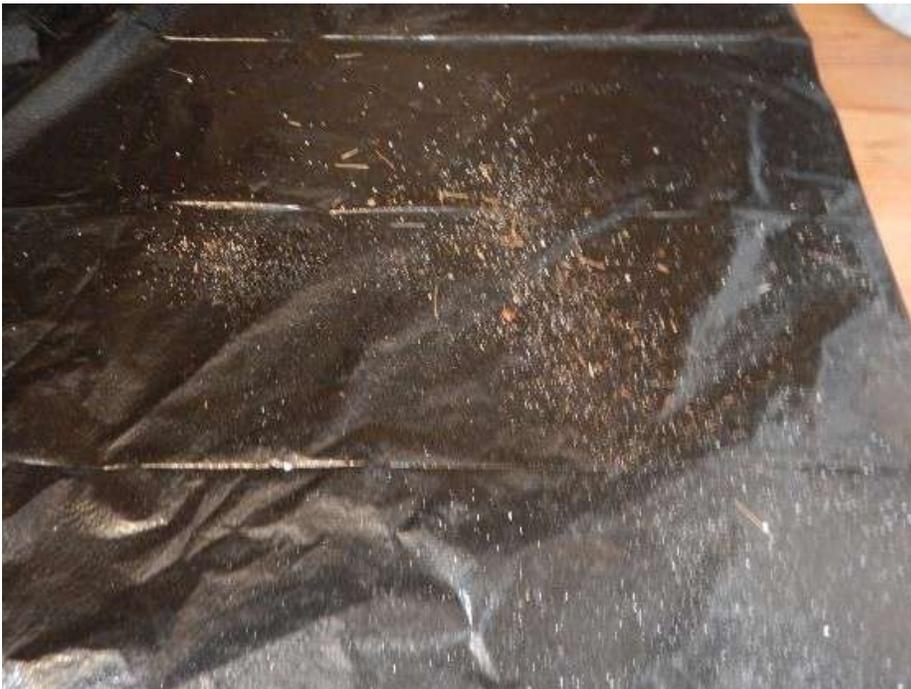
7. The visual evidence of the effects of accidental disturbance was dramatic with substantial debris on the floor of the room with no *MoldHold*.

<i>MoldHold</i> Test for Asbestos			
Summary Of Floor Surface Results (Visual Data & MicroVac)**			
Location/Description	Visual Results (on black background)	Asbestos Structures- Chrysotile	Asbestos Concentration (s/cm ²) Chrysotile
Room with <i>MoldHold</i>	No particulates	No sample collected	No sample collected
Room without <i>MoldHold</i>	Extensive particulates	915	594,156
		111	72,078
